# MIDWEST FLOODS of 2008 & IN IOWA & WISCONSIN

## 3 Residential, Historic, and Commercial Buildings

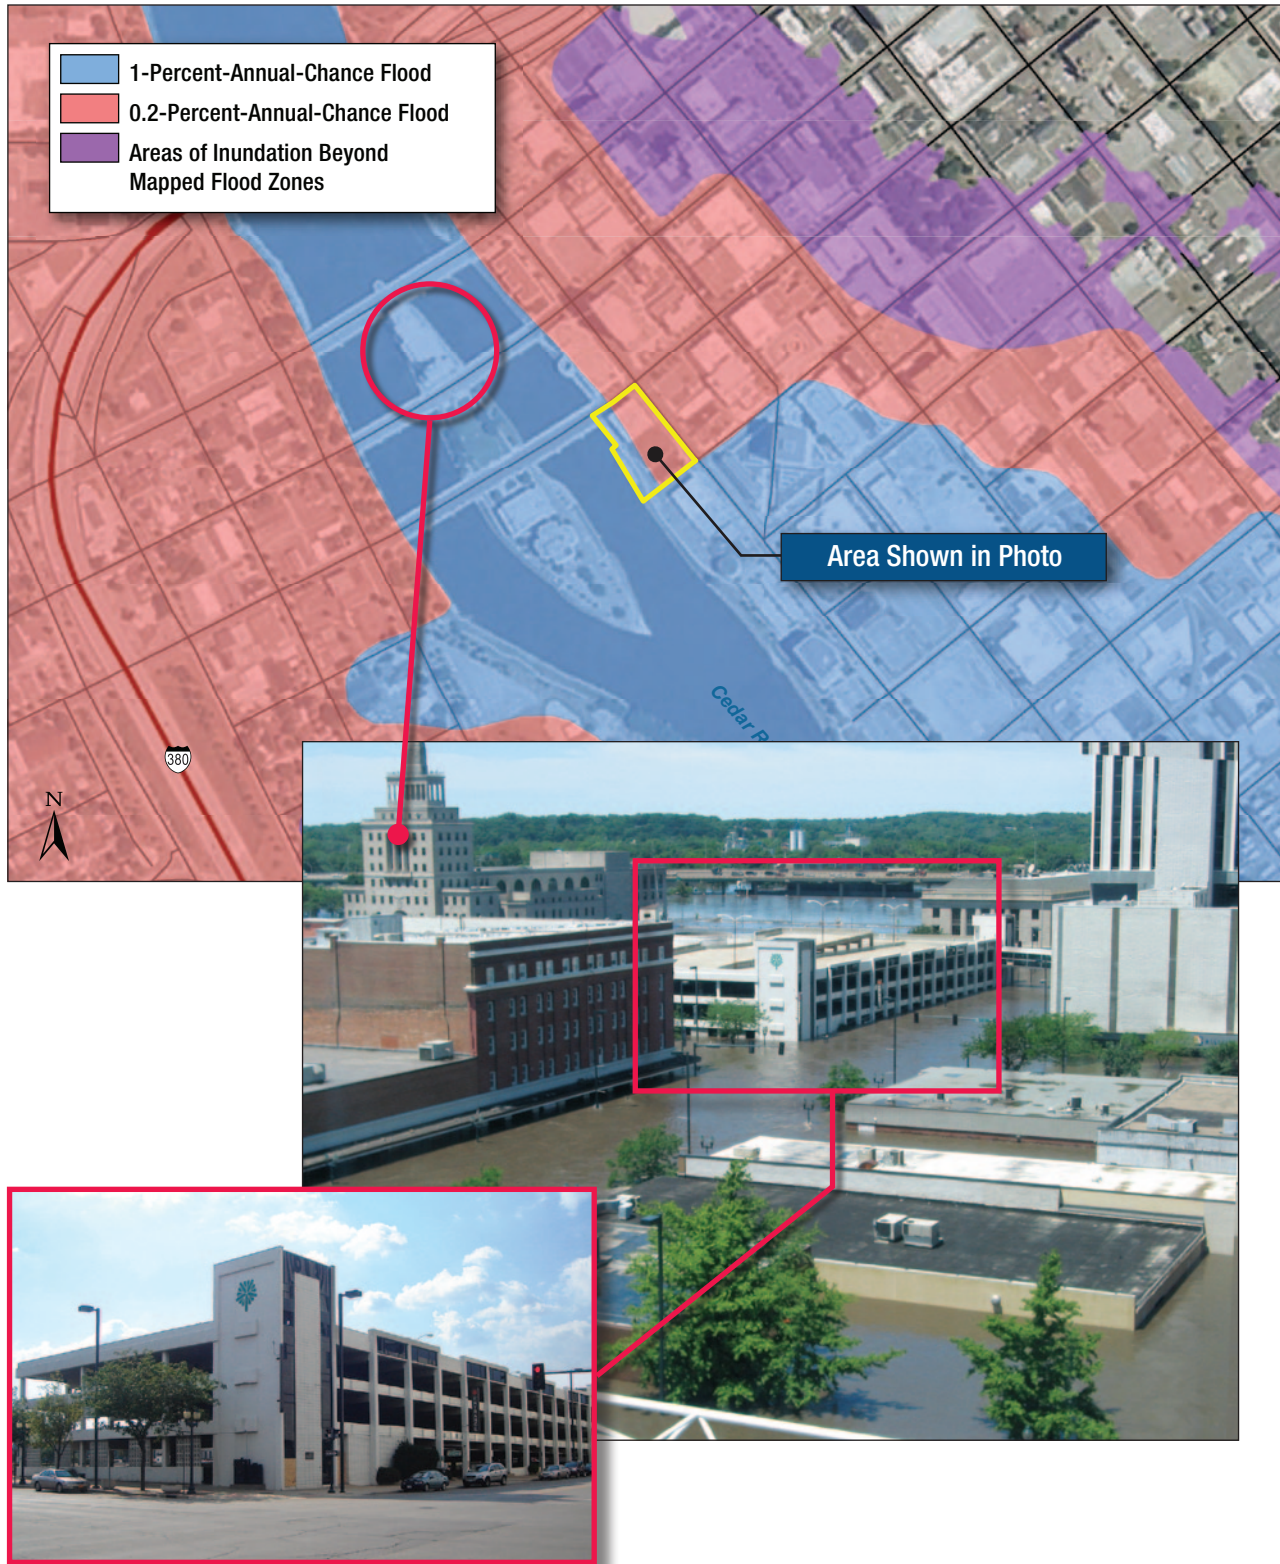
Figure 3-1.  
Floodwater in the downtown Cedar Rapids commercial district exceeded 6 feet in several buildings, as shown by the parking facility and surrounding properties (Cedar Rapids, Iowa).

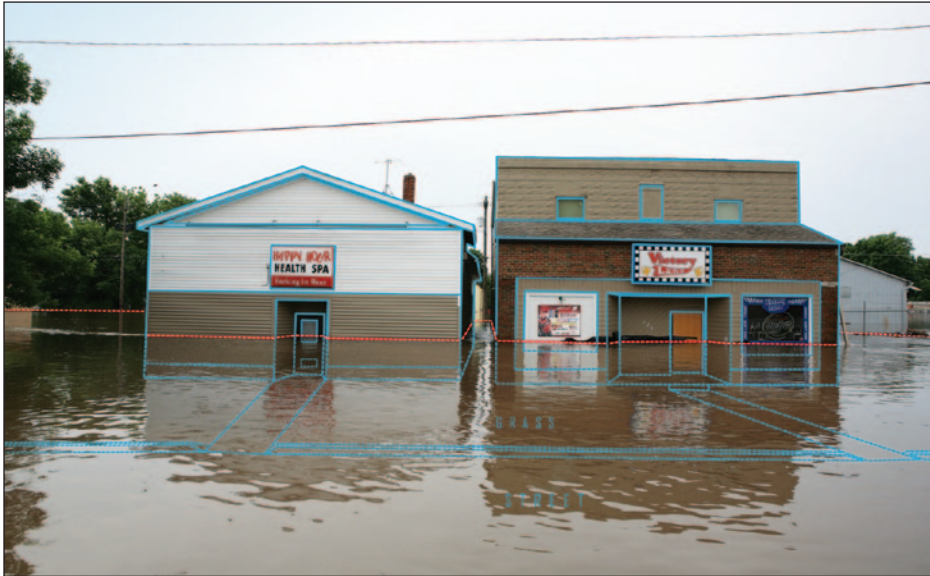
Figure 3-2 shows two buildings at the outer edge of the 0.2-percent-annual-chance flood zone (see also Figure 3-3). The waters were 4 feet above the first floor elevation at this location. This example highlights the residual risk and possibility of unexpected damage anywhere adjacent to even the 0.2-percent-annual-chance floodplain.

Figure 3-2.  
Floodwaters covered 1,300 blocks and 9.2 square miles of Cedar Rapids (Cedar Rapids, Iowa).

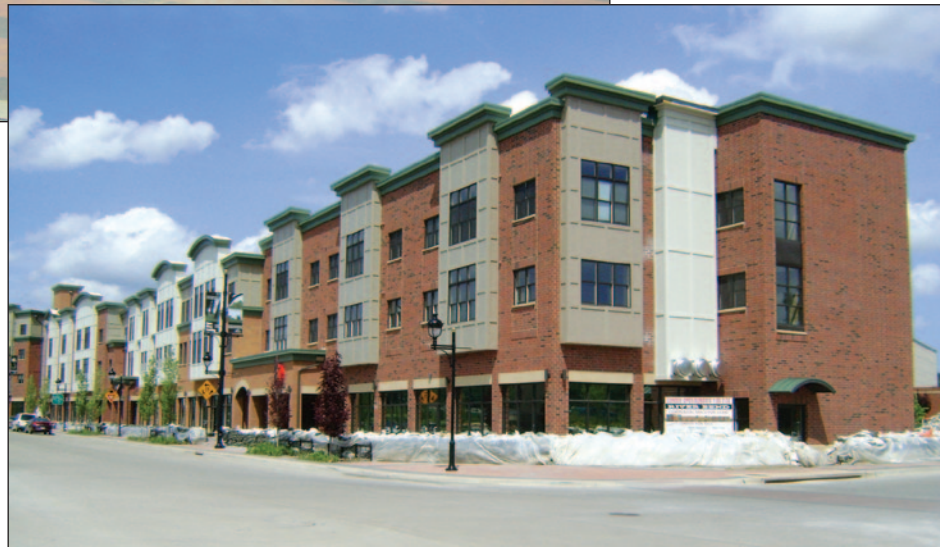
**Figure 3-10.**  
Although the Conference Center suffered minor damage, the adjacent buildings had extensive interior damage on the first floor (Coralville, Iowa).

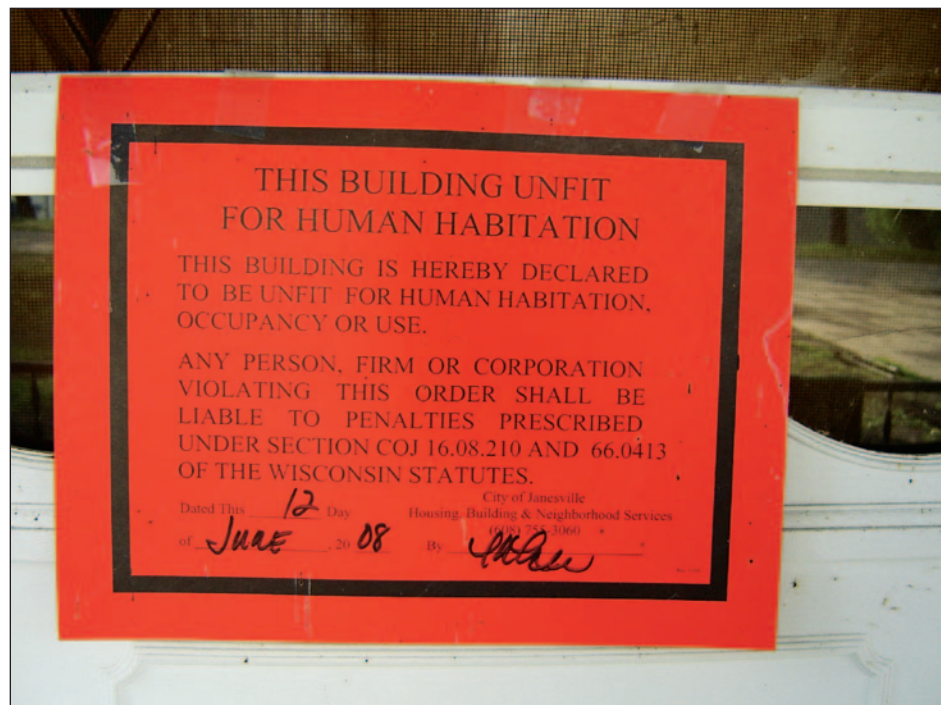
**Figure 3-12.**  
Sample placard for  
a building that was  
deemed unsafe to enter  
by inspectors (Janesville,  
Wisconsin).

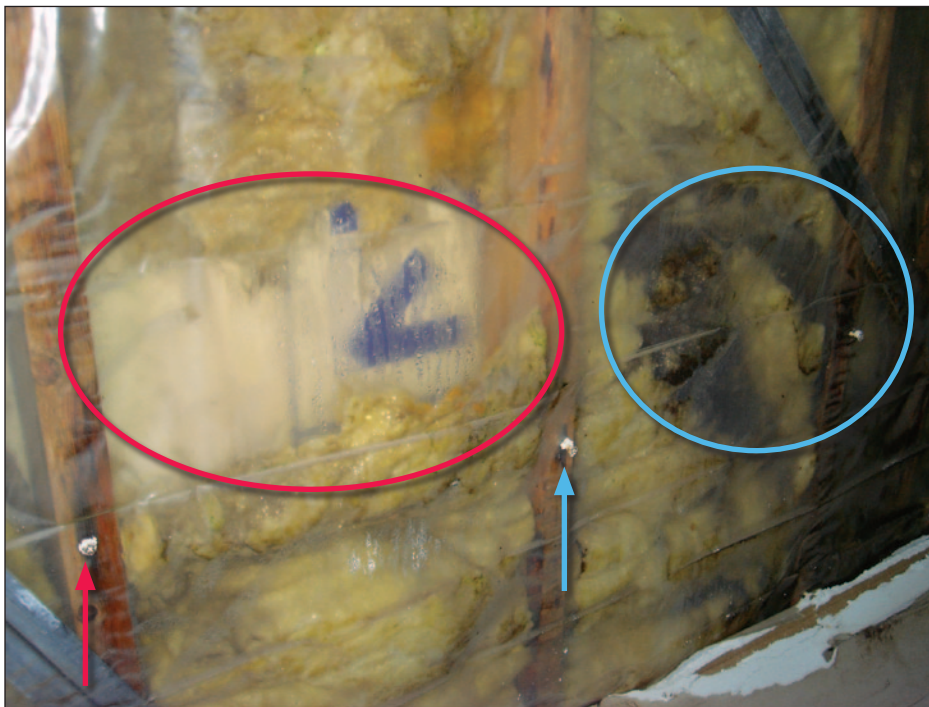
Figure 3-18.

Condensation can be seen beading up on the inside face of the vapor barrier (red circle). The increased humidity has initiated the growth of black mold (blue circle), started the rusting of the nails (blue arrow), and the wood is still wet as can be seen by the dark patches on the studs (red arrow) (Cedar Rapids, Iowa).

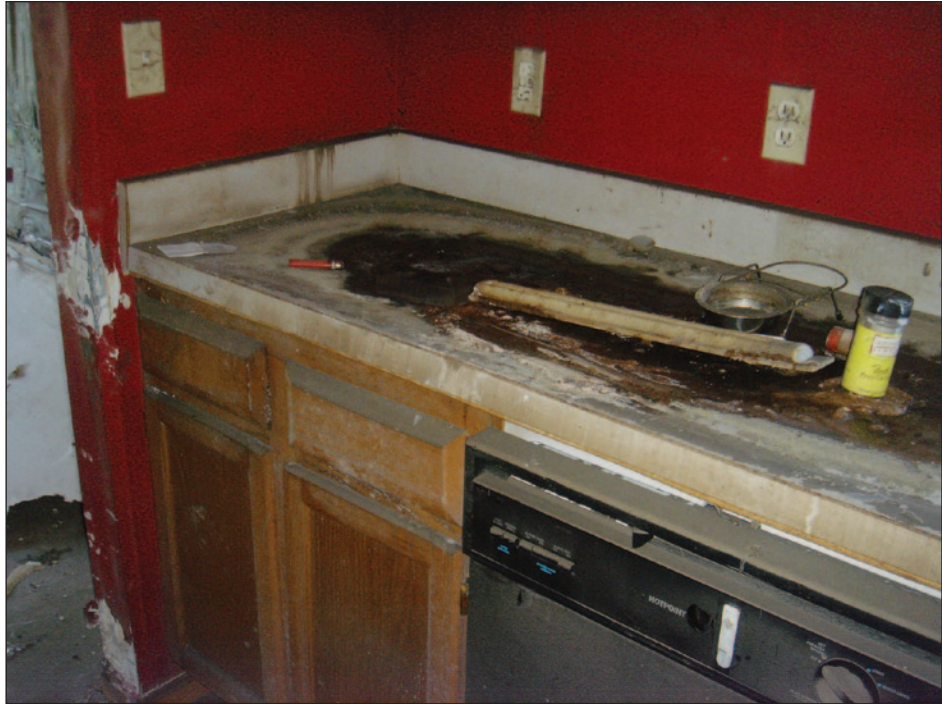
**Figure 3-19.**

The kitchen countertops, cabinets, appliances, etc., had been submerged and destroyed (Cedar Rapids, Iowa).

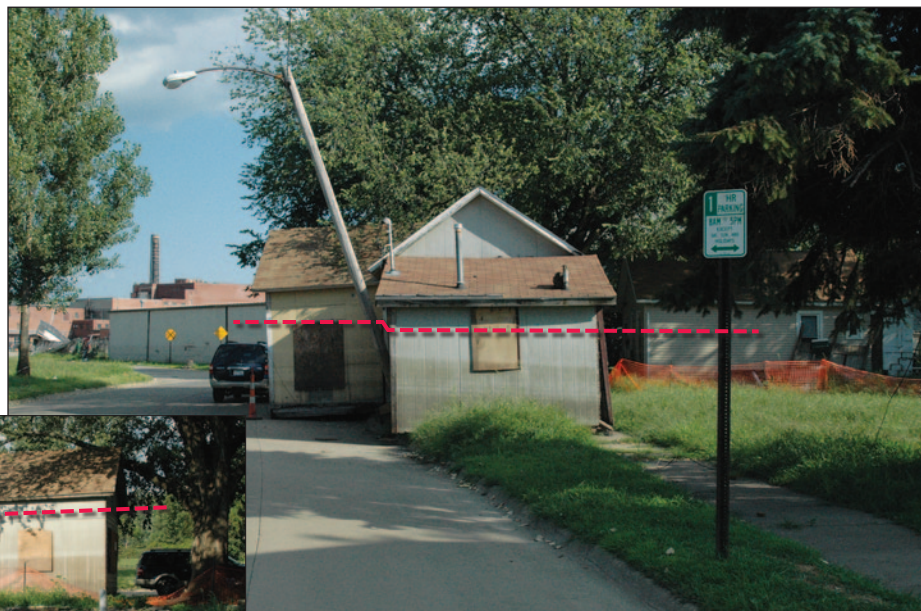
**Figure 3-20.**

Some buildings located in the area of inundation were displaced from their foundations because they lacked sufficient connections to secure them. Figure 3-20 shows an older masonry foundation that did not have adequate connections to anchor the structure.

This pre-FIRM house located in the SFHA was displaced from its foundation into the roadway adjacent to it. The photo below shows the building's original location. The red line indicates the depth of flooding (Cedar Rapids, Iowa).

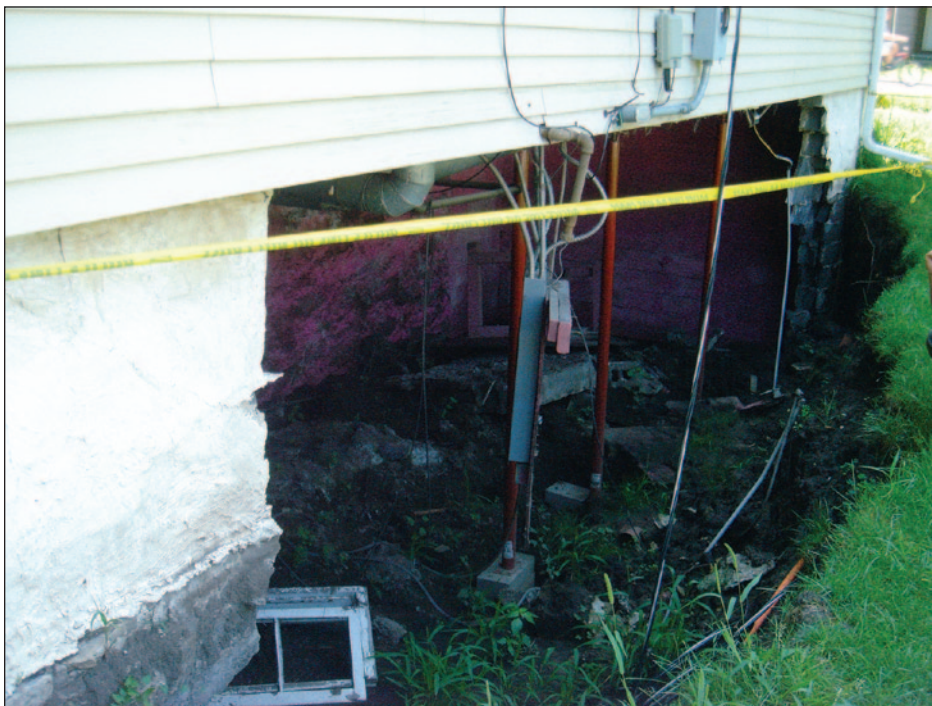
The most common form of structural damage to residential buildings observed by the MAT was the failure of foundation walls, especially those constructed of unreinforced masonry, as a result of lateral pressures from saturated soils and hydrostatic pressure, as illustrated in Figures 3-21 to 3-27.

**Figure 3-21.**  
Failure of unreinforced masonry foundation walls due to hydrostatic pressure observed in various locations in Iowa.

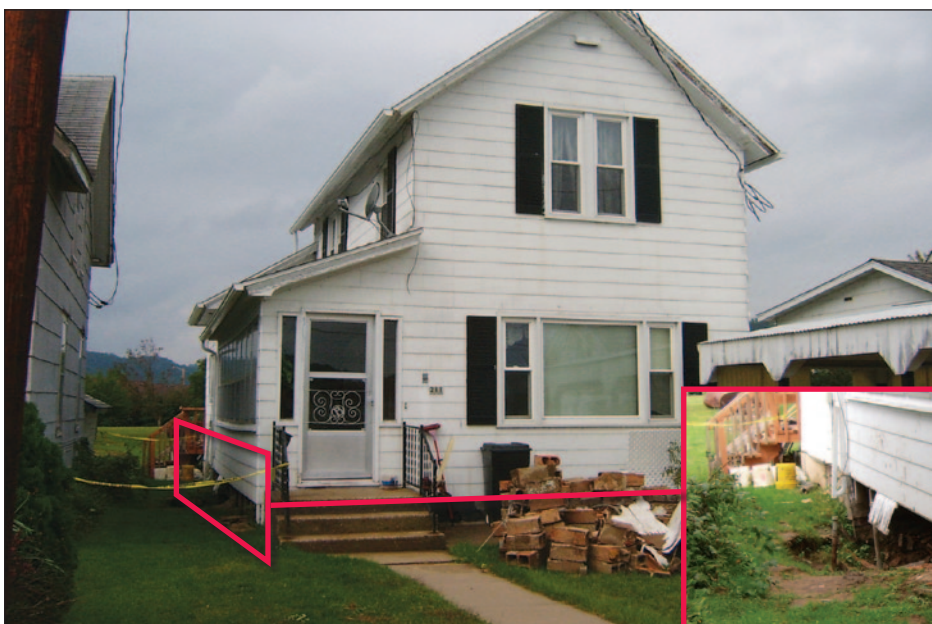
**Figure 3-22.**  
Collapse of a foundation wall due to hydrostatic forces (Viola, Wisconsin).

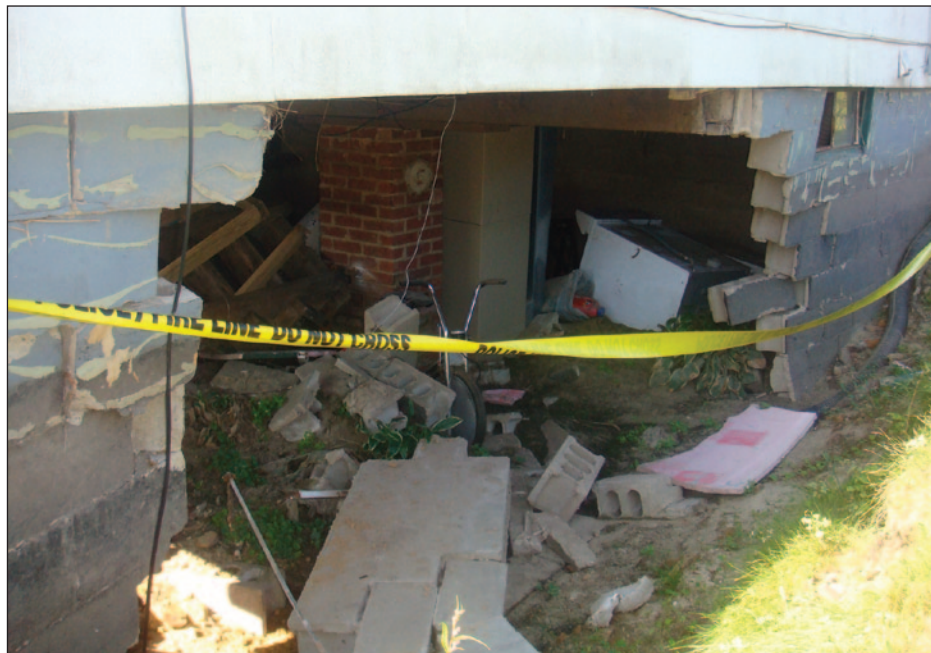
**Figure 3-24.**  
This basement wall failed and almost collapsed due to lateral pressures from saturated soils (Shell Rock, Iowa).

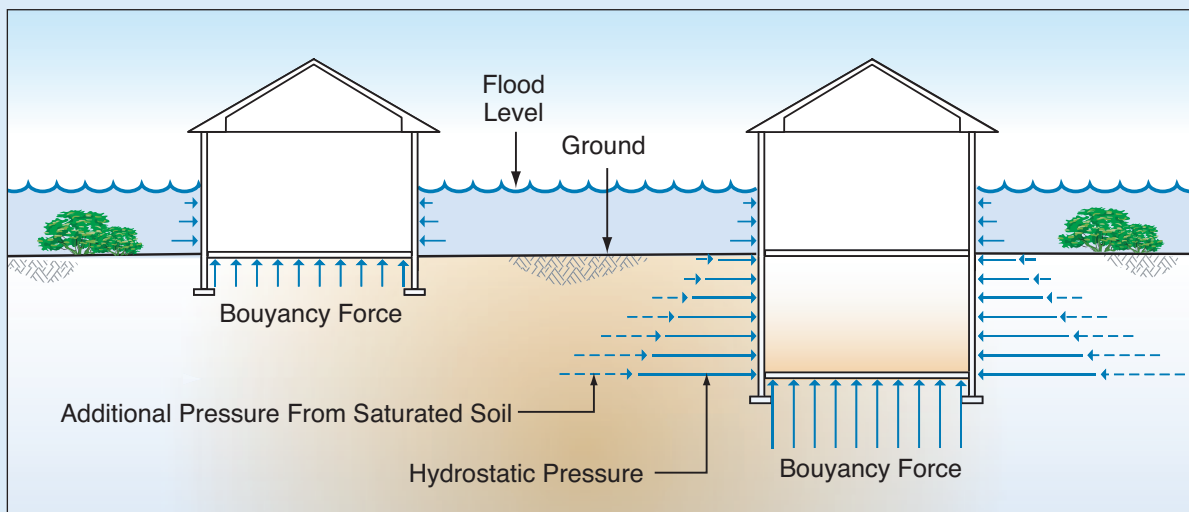
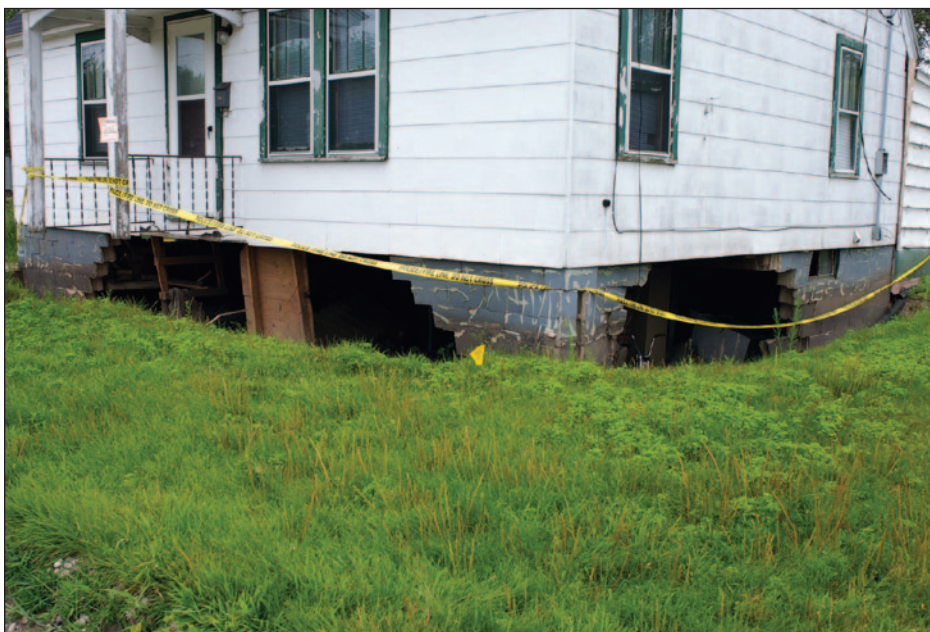
Figure 3-25.  
This house had two walls that were damaged due to hydrostatic pressure (Reedsburg, Wisconsin).

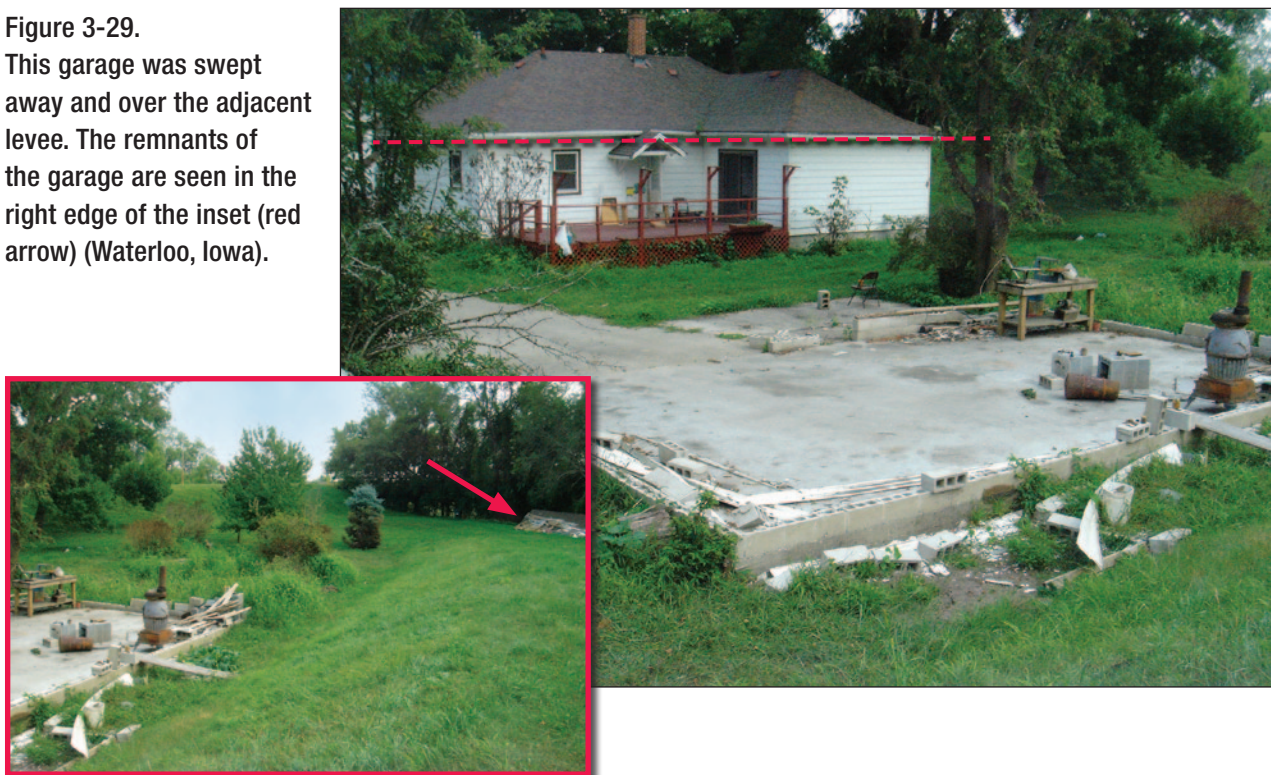
Figure 3-29.  
This garage was swept away and over the adjacent levee. The remnants of the garage are seen in the right edge of the inset (red arrow) (Waterloo, Iowa).

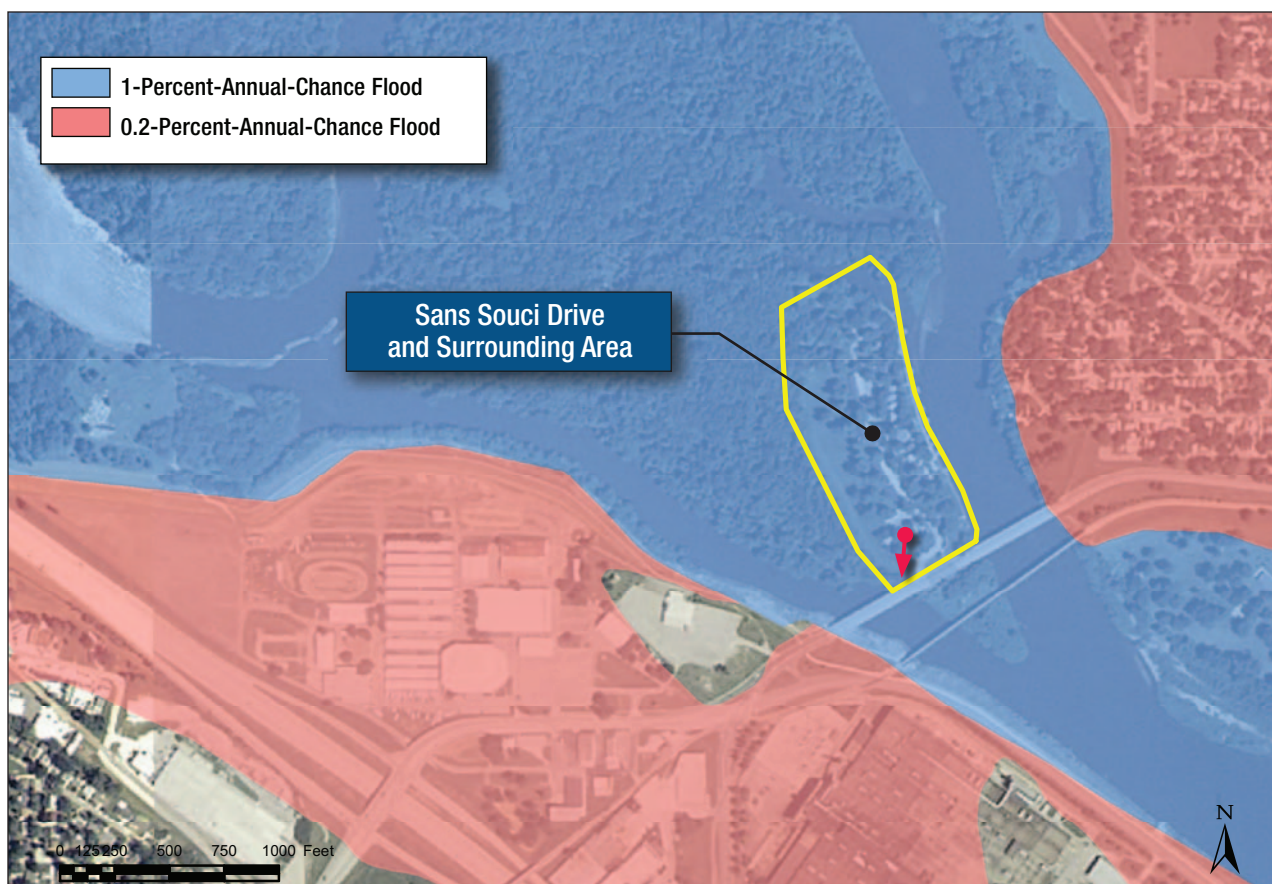
Figure 3-30.

The red arrow traces the path of the displaced structure shown in Figure 3-29. The debris field was found approximately 250 feet away from its origin (Waterloo, Iowa).

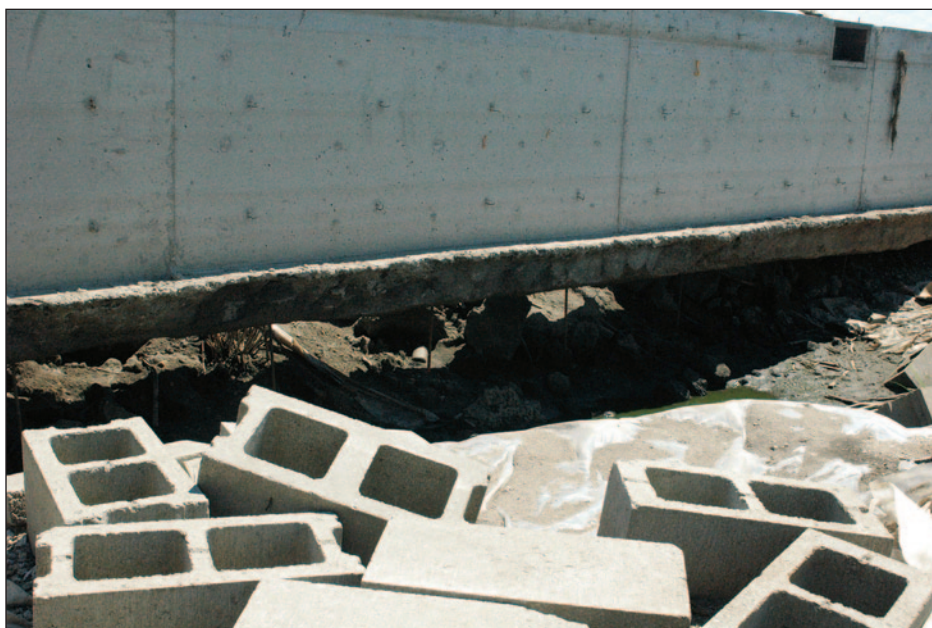
Figure 3-31.

This foundation wall was subject to scour caused by high-velocity flow after a levee was overtopped by floodwater (Oakville, Iowa).

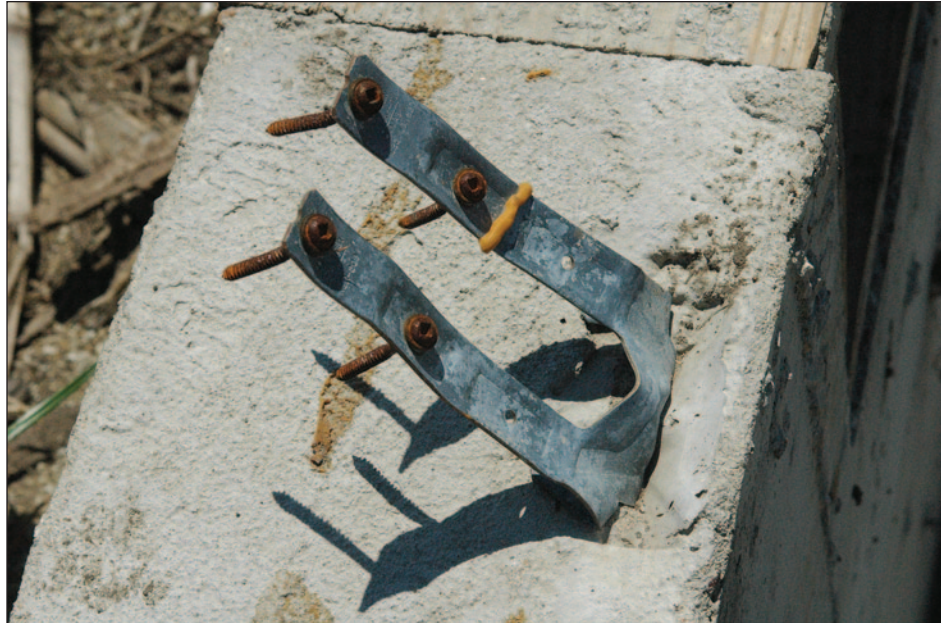
**Figure 3-32.**  
These failed connections were used to secure a home to a reinforced concrete foundation wall and were spaced every 6 to 7 feet (Oakville, Iowa).

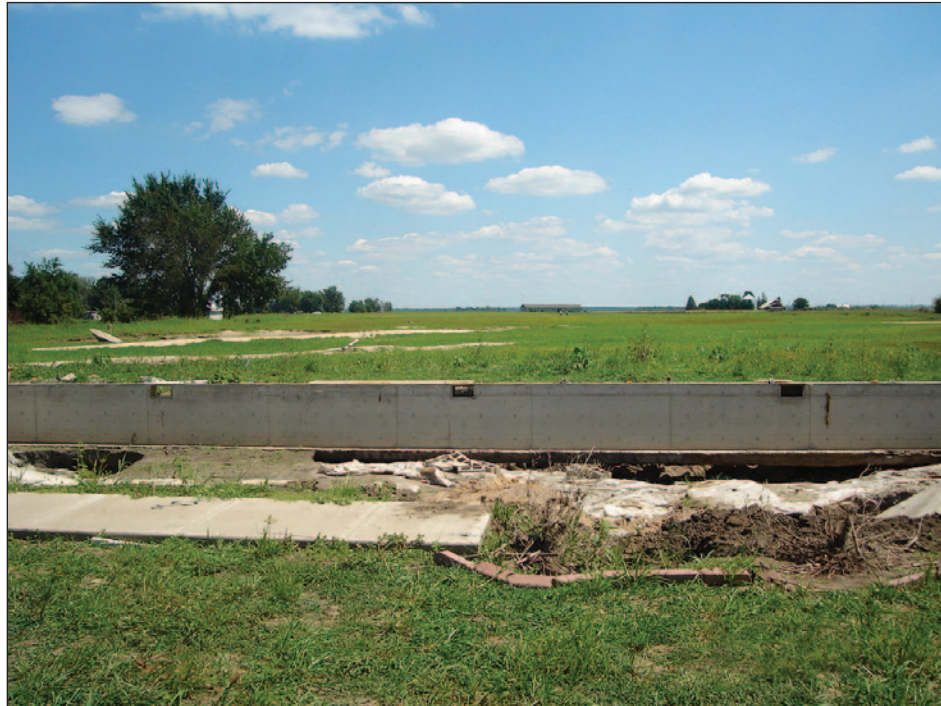
**Figure 3-33.**  
The home that was on this foundation was moved several hundred feet away by the floodwater that overtopped a levee (Oakville, Iowa).

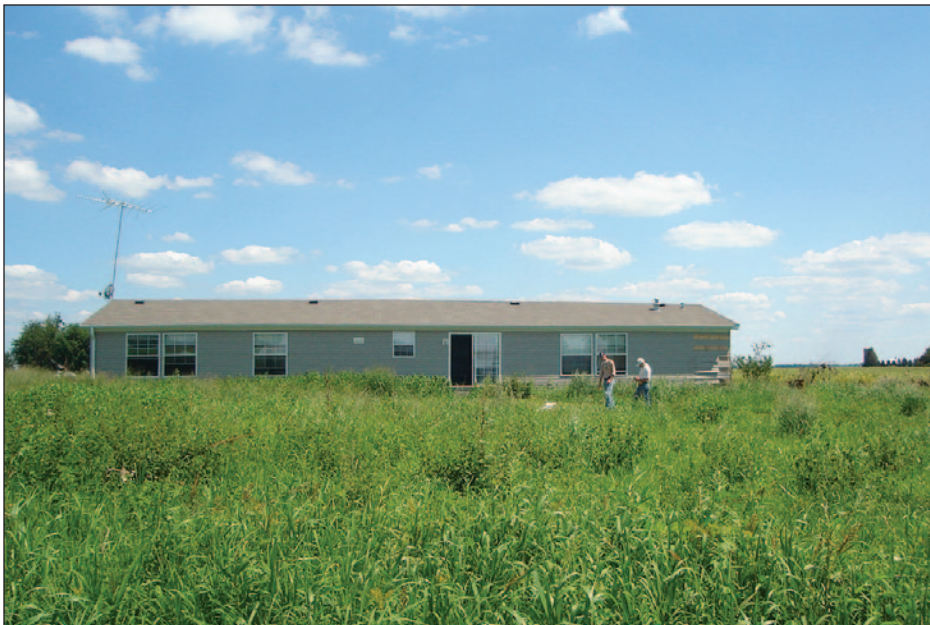
Figure 3-34.  
The home actually remained intact after being forced away from its foundation (this is the same manufactured home referenced in Figures 3-31 to 3-33) (Oakville, Iowa).

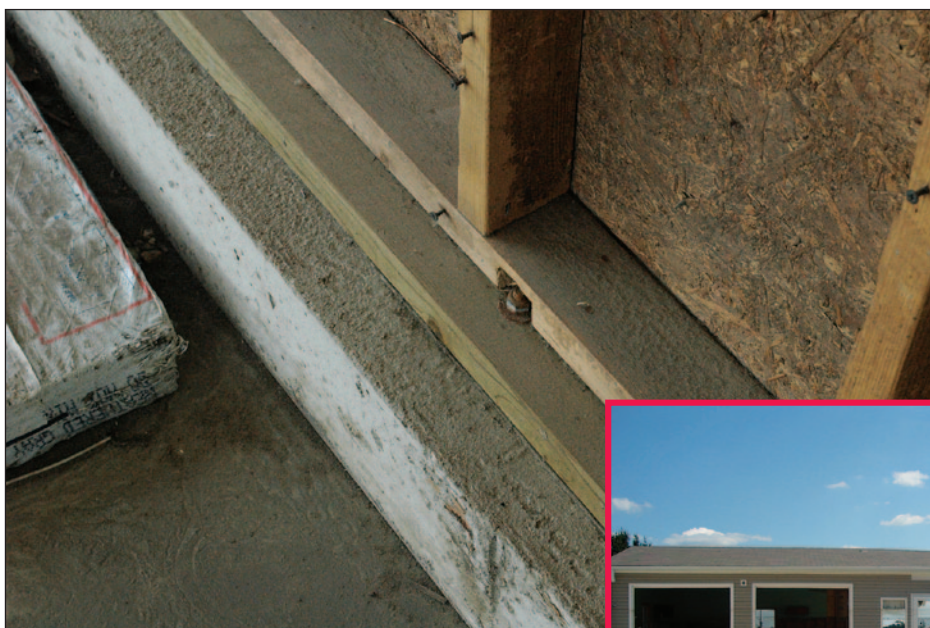
Figure 3-35. The framing for the portion of the home that remained in place was bolted down to the foundation (this is the same manufactured home referenced in Figure 3-31 through 3-34) (Oakville, Iowa).

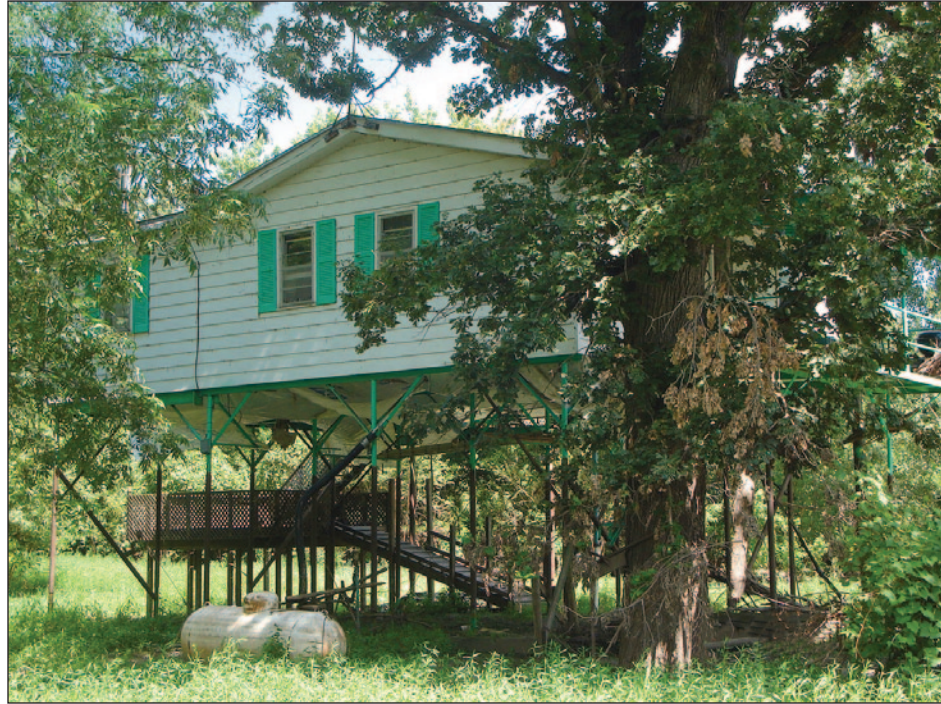
**Figure 3-37.**  
Residential building constructed on open foundation that suffered considerably less damage than those on closed foundations in the same area. Slender columns such as those shown here offer little resistance to lateral loads that can occur from flooding and debris. Accounting for gravity and lateral loads, not just elevation, should be considered during design (Oakville, Iowa).

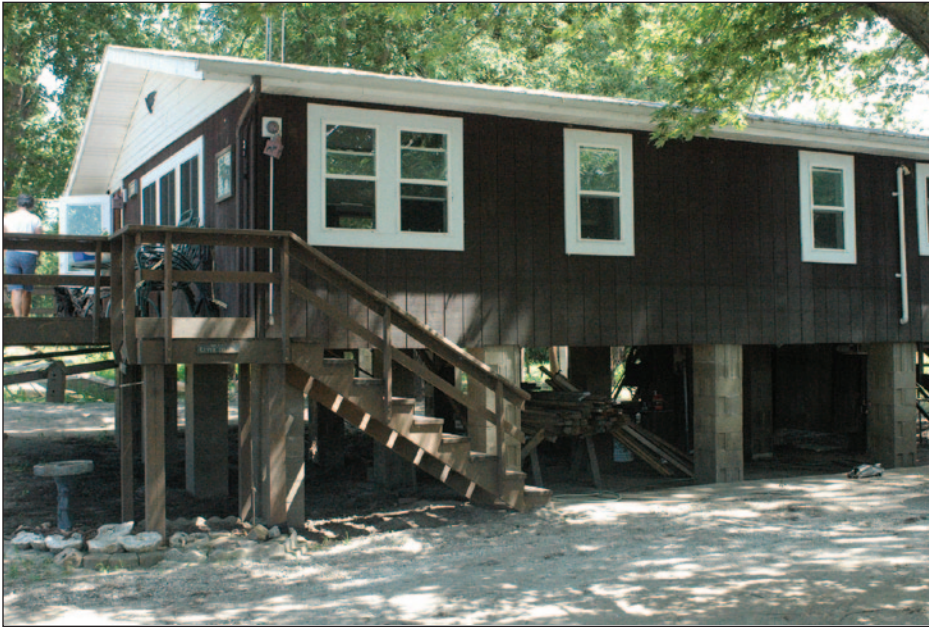
Figure 3-38. Residential building constructed on open foundation that suffered considerably less damage than those on closed foundations in the same area (Oakville, Iowa).

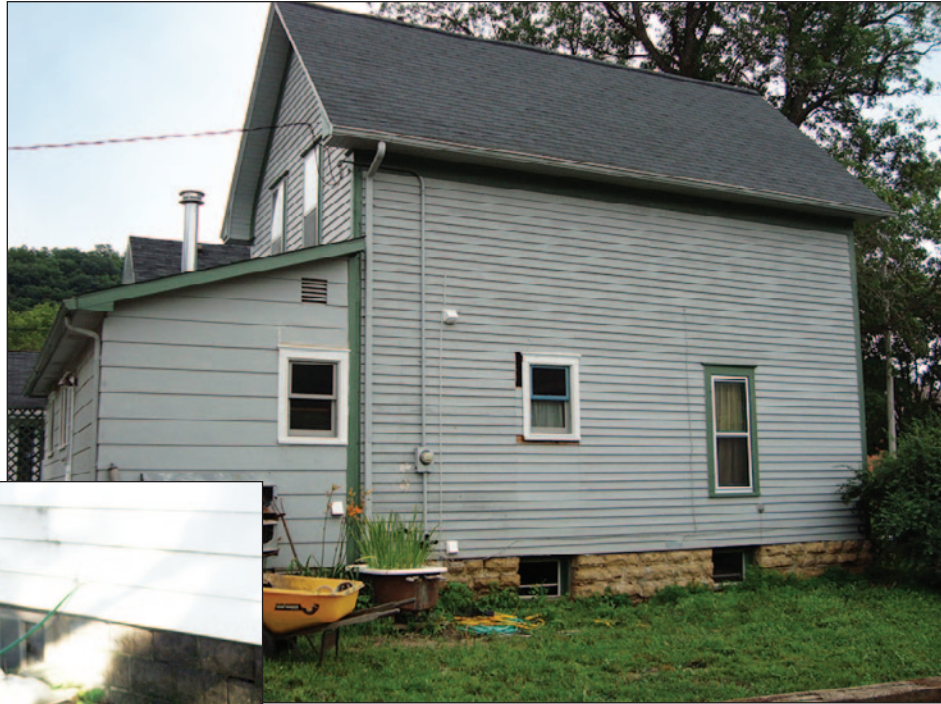
**Figure 3-40.**  
This basement sustained damage to the mechanical and plumbing systems of the home (Waverly, Iowa).

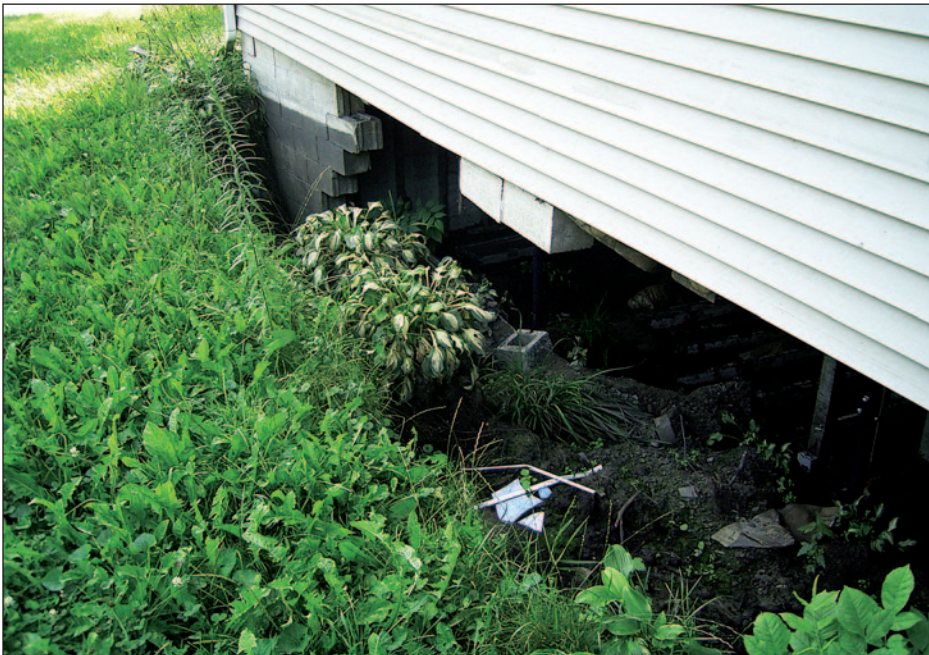
**Figure 3-42.**

This foundation wall collapsed when the homeowner prematurely pumped water out of the basement (Palo, Iowa).

After a flood, homeowners should exercise extreme caution if their basement is inundated. Homeowners should not pump water out of a basement immediately following a flood. Even after the flood crest has passed and floodwater has receded, homeowners should avoid removing water from a basement too quickly so as to prevent basement wall and floor failure due to hydrostatic forces. Although most property owners impacted by the 2008 floods knew not to pump out their basements, Figure 3-42 provides an example of a basement that was pumped out too soon.

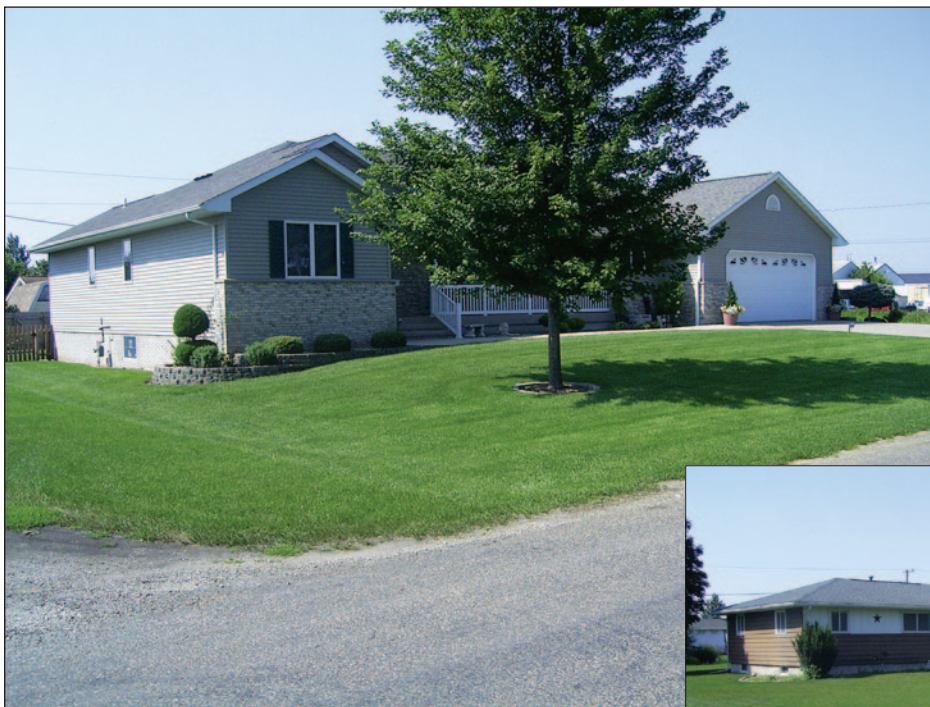
Damage in one newly engineered basement was reported by a homeowner where floodwater exceeded the floodproofing design elevation. These damages were in a basement just outside the SFHA (see Figure 3-44).

Figure 3-44.  
This house located just outside the SFHA suffered no damage on the first floor (unlike the adjacent property), but the basement suffered damages to architectural finishes, electrical systems, and contents (Palo, Iowa).

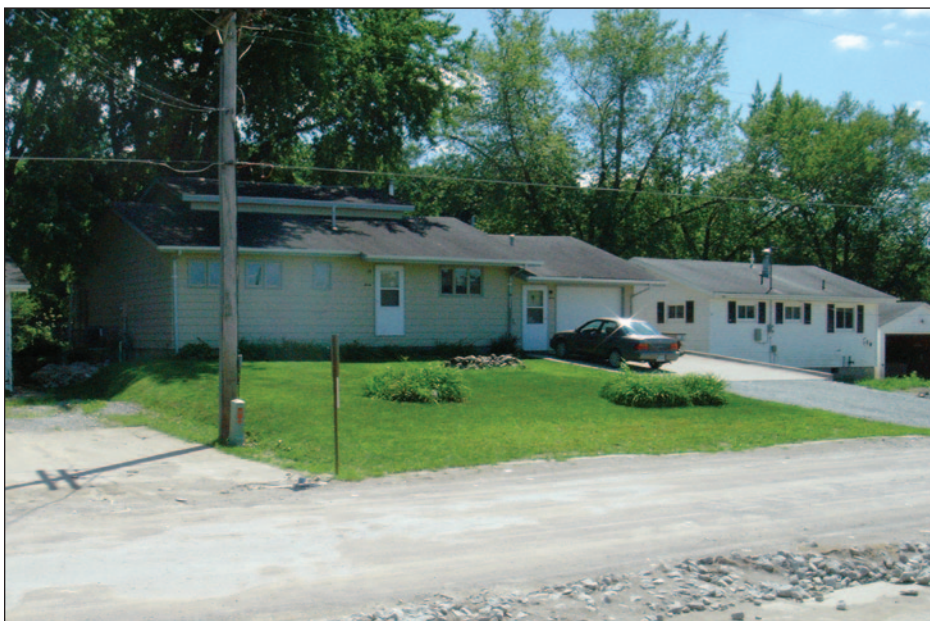
Figure 3-45.  
Completed elevation project where the basement was not removed; this violation was recorded prior to the 2008 floods (Coralville, Iowa).

It is important for communities to ensure basements are removed (unless properly approved) when substantially damaged properties are being elevated or reconstructed in the SFHA. Figures 3-45 and 3-46 are examples of completed and ongoing elevation projects where basements were kept in the SFHA.

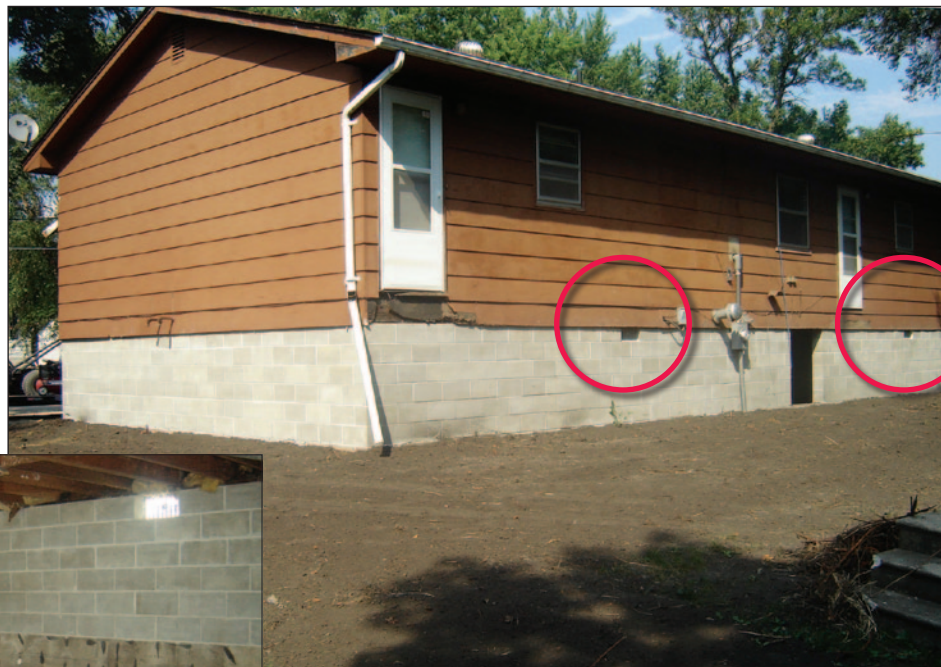
**Figure 3-50.**  
Recently completed  
elevation project, properly  
elevated above BFE;  
however, the foundation  
does not have openings  
at the proper height  
(red circles). The crawl  
space floor is at the same  
elevation as the exterior  
grade (New Hartford, Iowa).

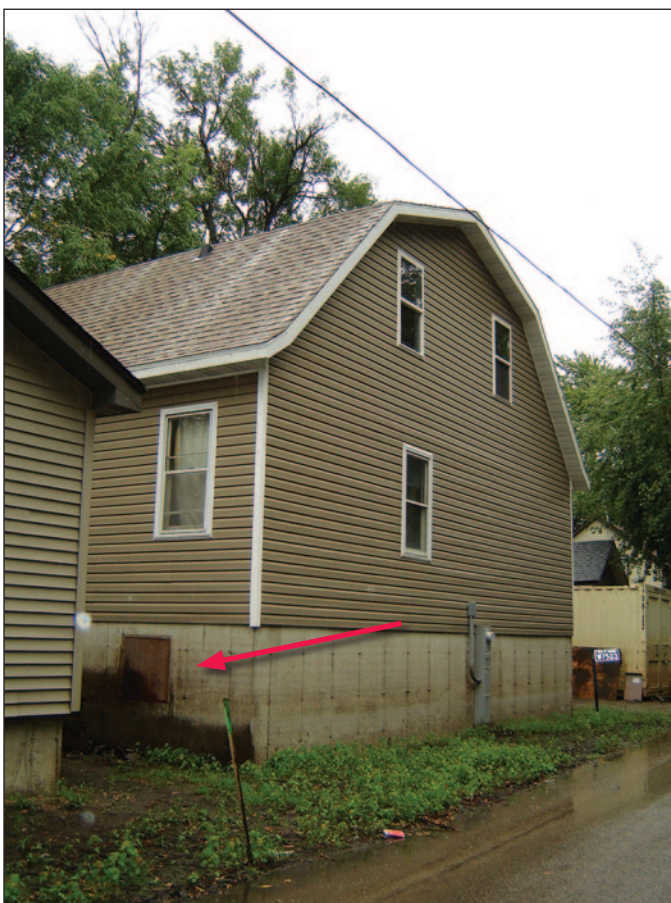
**Figure 3-56.**  
Foundation opening that does not conform to NFIP requirements for openings in foundation walls and walls of enclosures for structures in the floodplain (Blackhawk Island, Wisconsin).

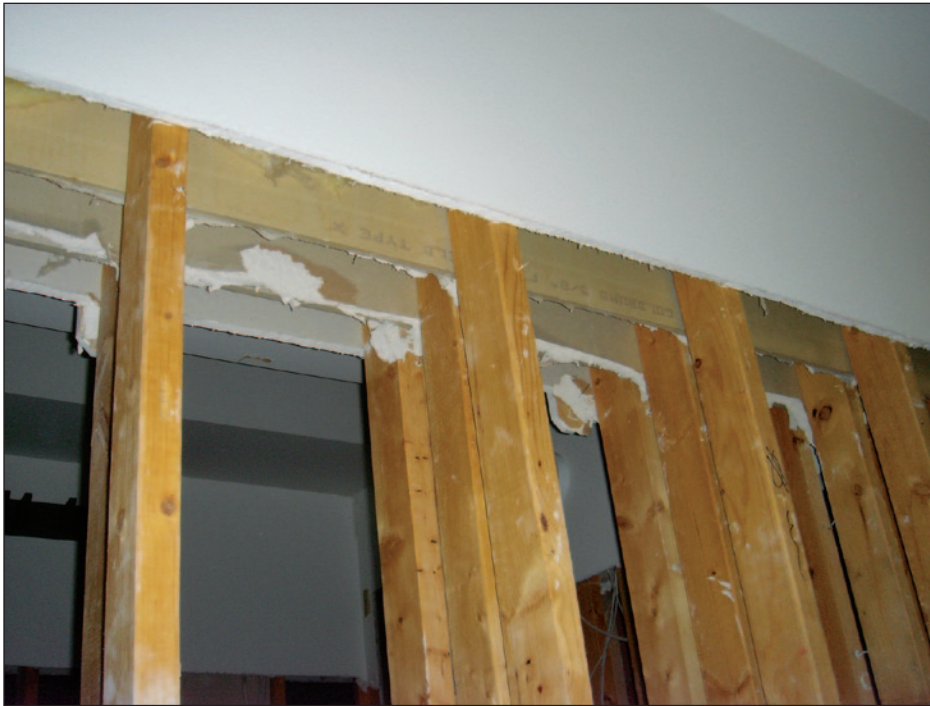
**Figure 3-73.**

One challenge noted by the MAT was the difficulty in repairing the party-wall between units in the Idyllwild community. The party-wall was constructed in three layers (see Figure 3-73). The gypsum wallboard was applied to each layer successively. Then the next portion of framing and another layer of gypsum wall board were installed. The floodwaters damaged all the layers of the drywall in the party-wall. The damaged material can be broken down and easily removed. New material comes in 4-foot by 8-foot or 4-foot by 12-foot sheets. But since the spacing between studs is 16 inches, there is no practical way to replace the inner sheets.

The majority of the units throughout the subdivision were uninhabitable two months after the event; several issues regarding re-occupancy will need to be resolved such as repair of the firewall system dividing the units (Iowa City, Iowa).

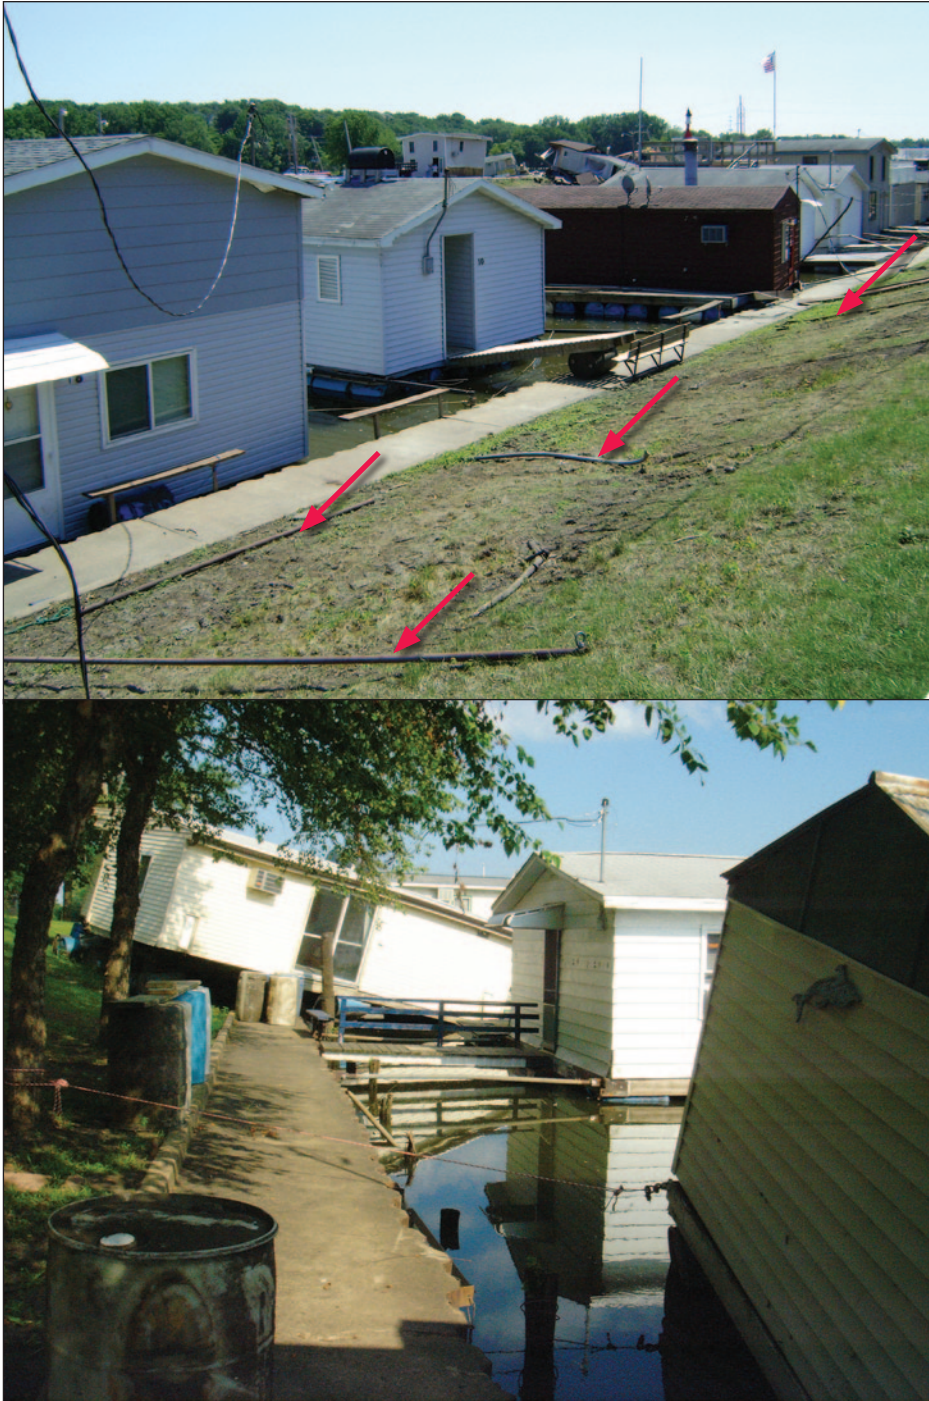
Figure 3-75.  
Typical boathouse in the  
Ellis Boat Harbor. Red  
arrows point to damaged  
anchorages (Cedar Rapids,  
Iowa).
